REMEDIAL INVESTIGATION ADDENDUM:

SUPPLEMENTAL PRELIMINARY ASSESSMENT
OF THE
WILLAMETTE COVE UPLAND FACILITY
PORTLAND, OREGON

**Port of Portland
121 NW Everett
Portland, Oregon 97209**

September 19, 2003

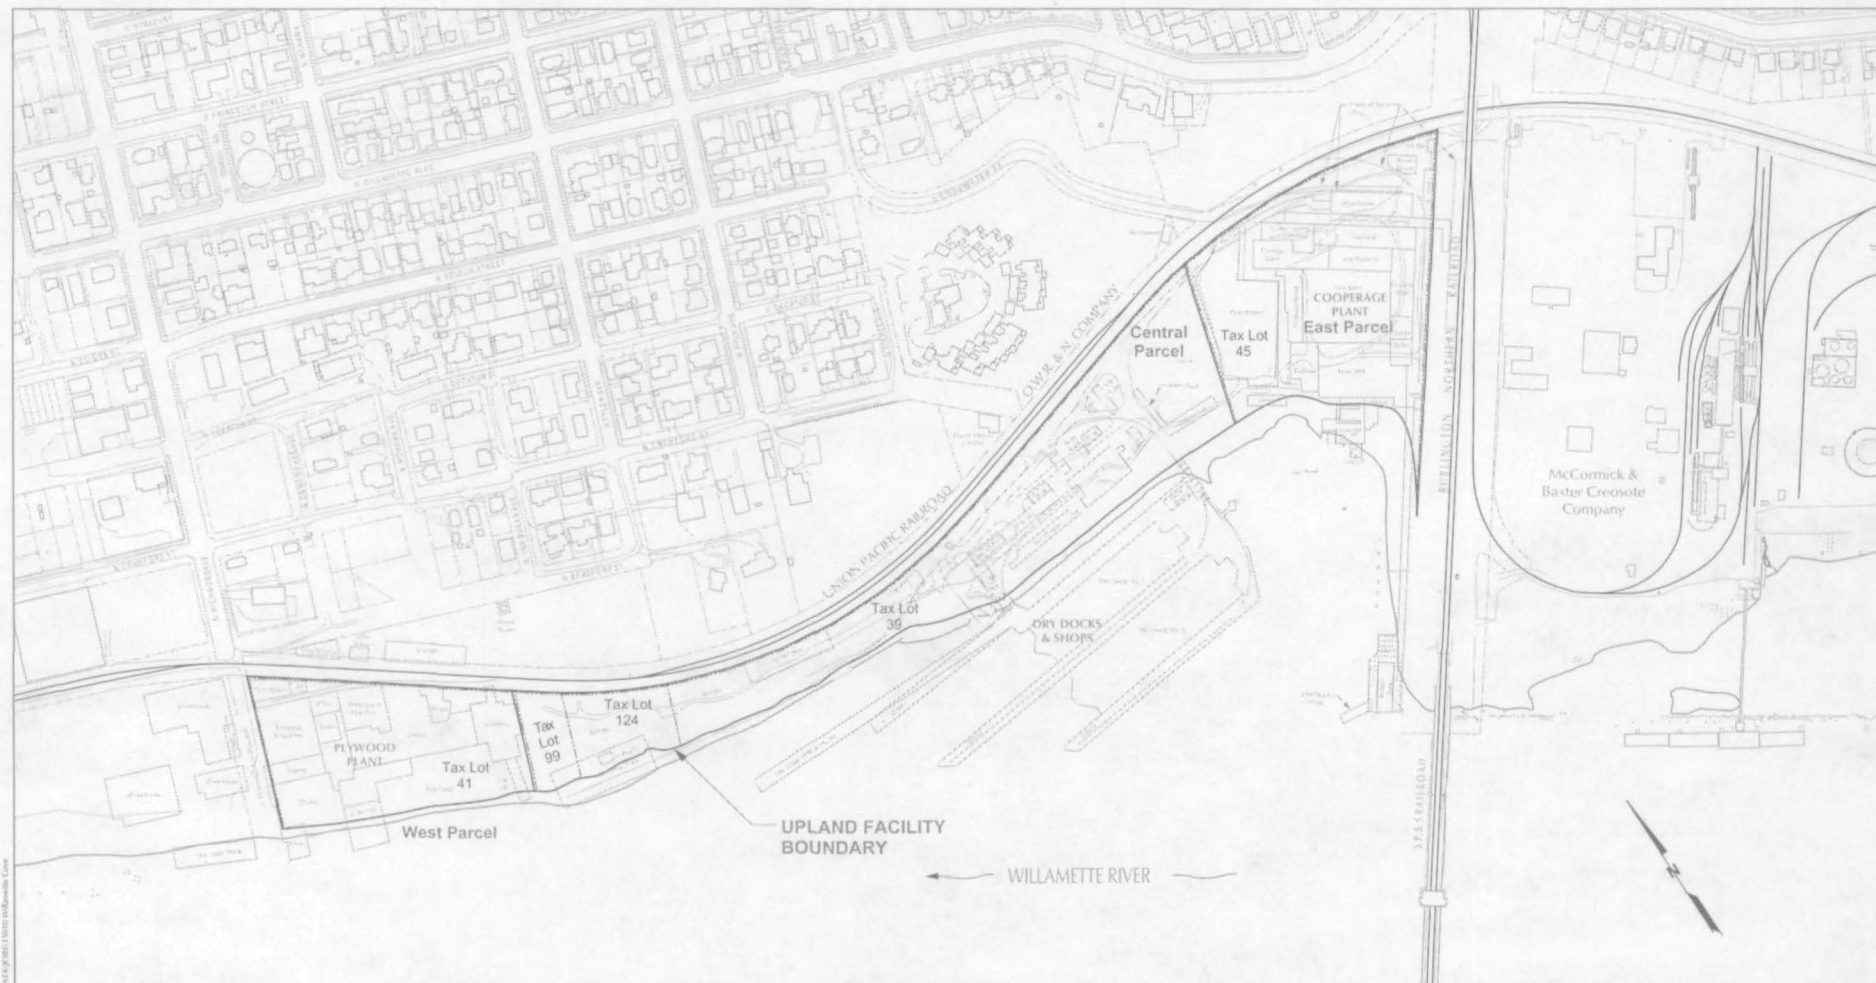
Historical Plan of the Upland Facility
 Willamette Cove
 Portland, Oregon

| Railroad Tracks | Scrimsier Company Sawmill (~ 1960) |

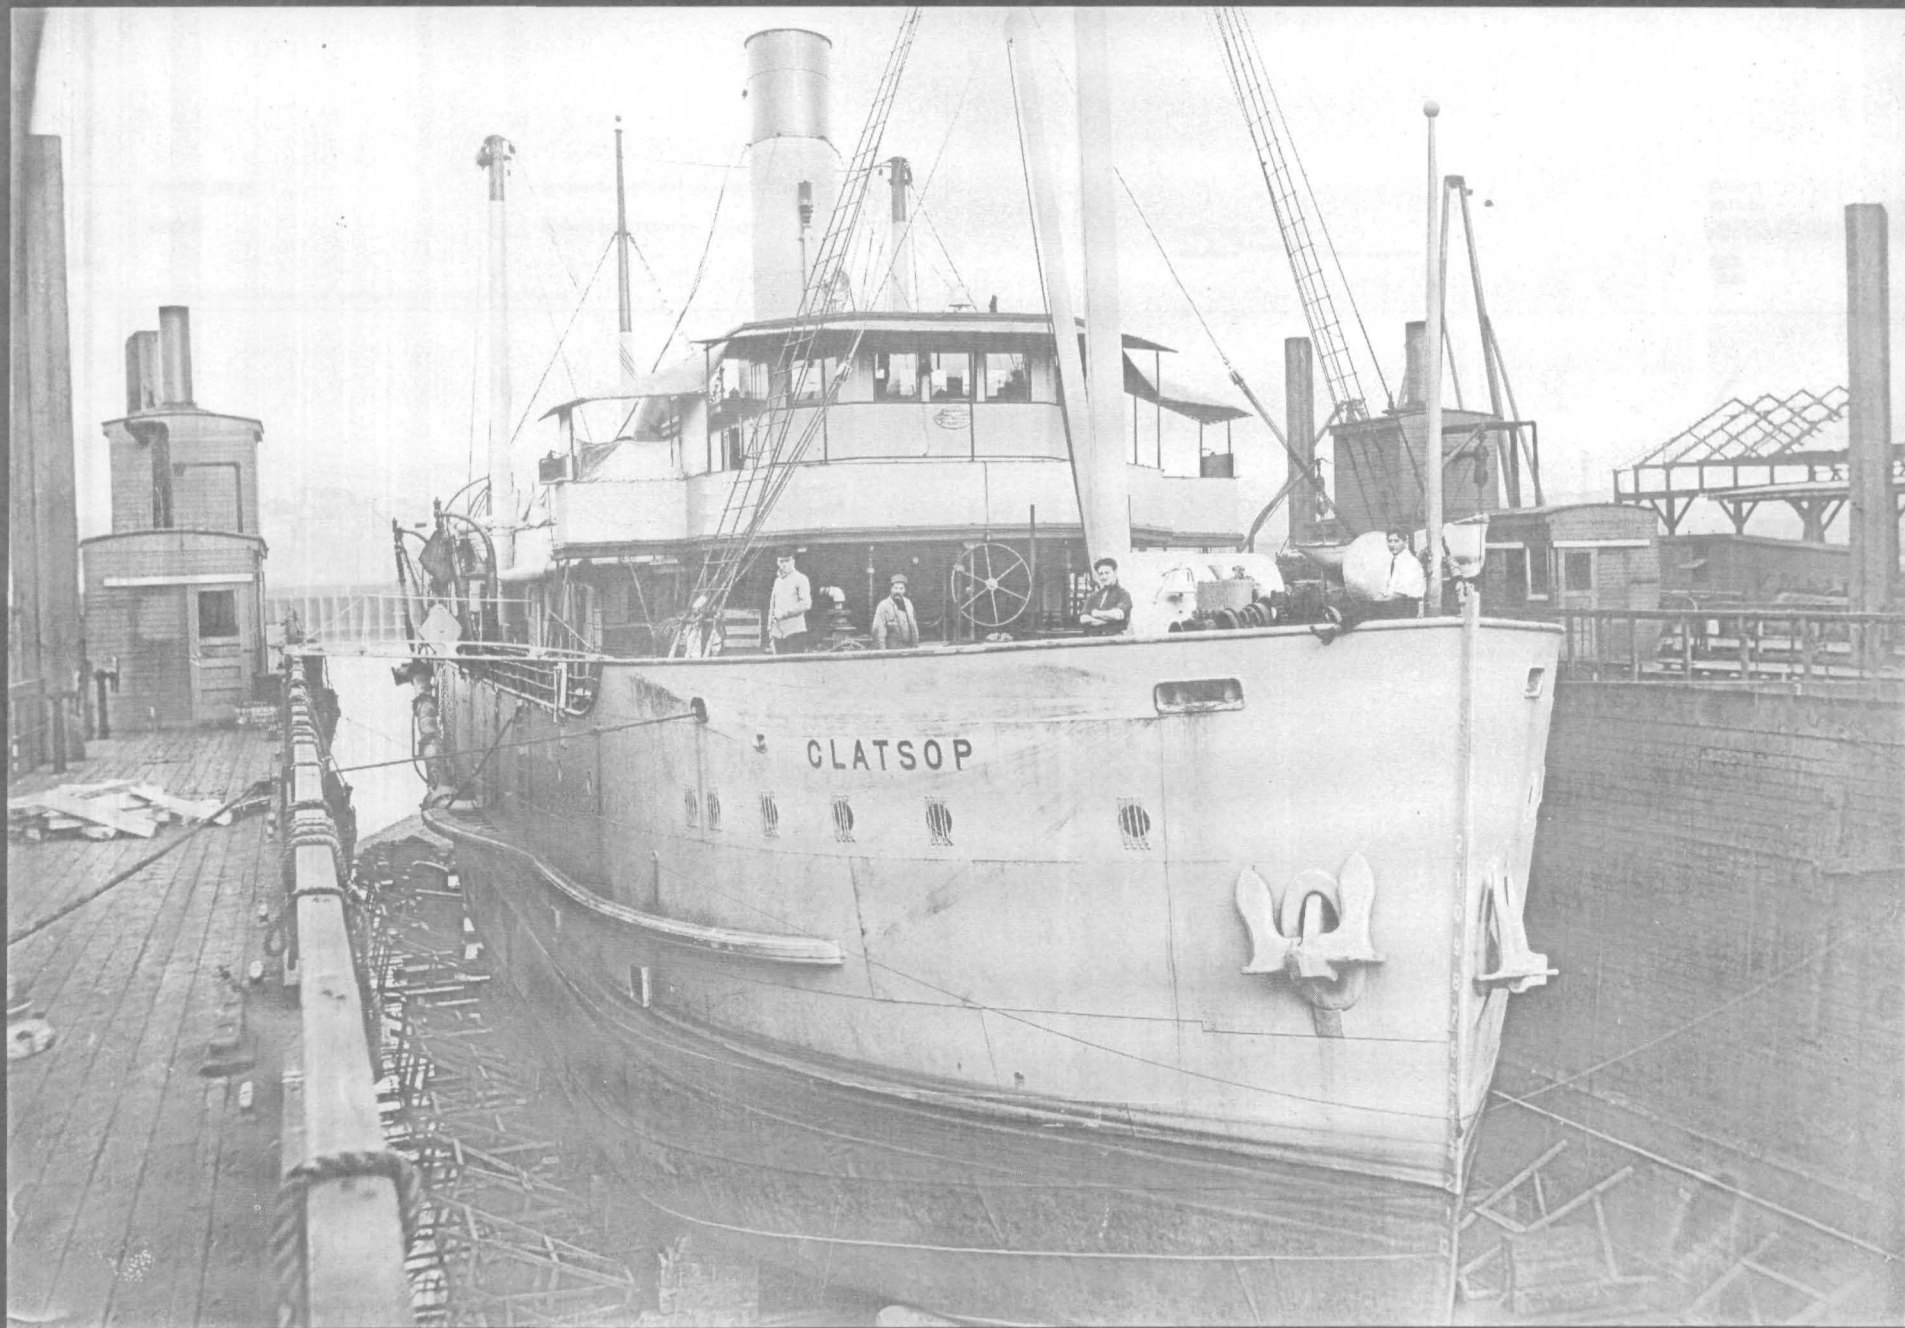
PH DD 1912 4001 00 0001 0

U.S. Dredge Clatsop self propelled and hopper-bottom.
At Oregon Dry Dock 1912
